TECHNICAL MEMORANDUM

Date: February 7, 2018

Subject: Leavitt Reservoir Expansion Project – Non-wetland Woody Riparian Inventory

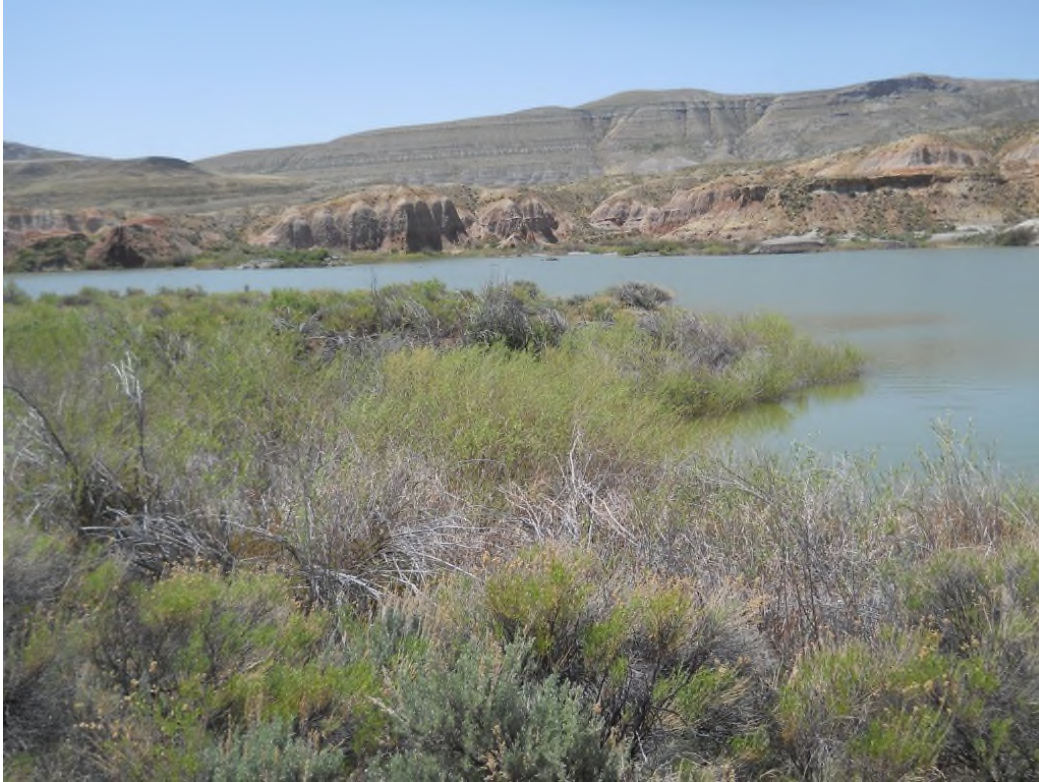
Photograph 1. Representative shrub-willow community along the reservoir fringe.

There were 1.37 acres of non-wetland woody riparian communities identified along the existing reservoir margins (Table 1; Photo 1 and 2; polygons 3-6). Sandbar willow was the dominant species, with smaller percentages of Russian olive and salt cedar (*Tamarix chinensis*). Both Russian olive and salt cedar are classified as noxious weeds in Wyoming. In many locations, these polygons abutted palustrine scrub-shrub wetlands. The fringe areas occur in the proposed and existing embankment and inundation areas.

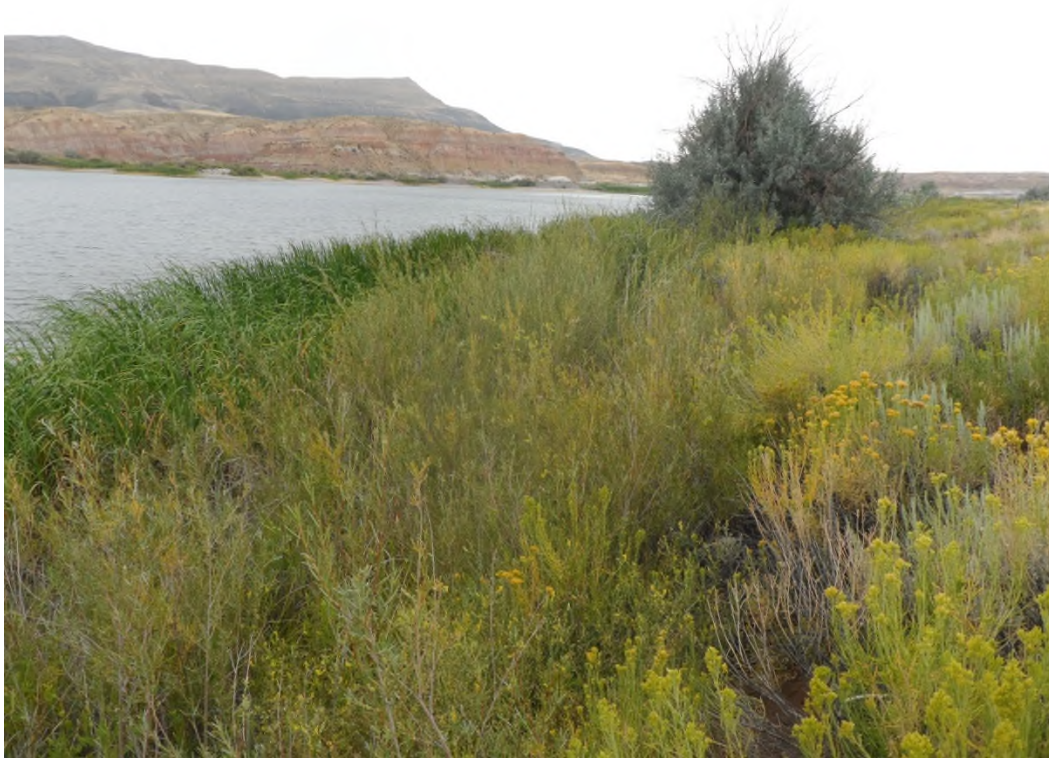
Photograph 2. Representative willow and scattered Russian olive community along the reservoir fringe.

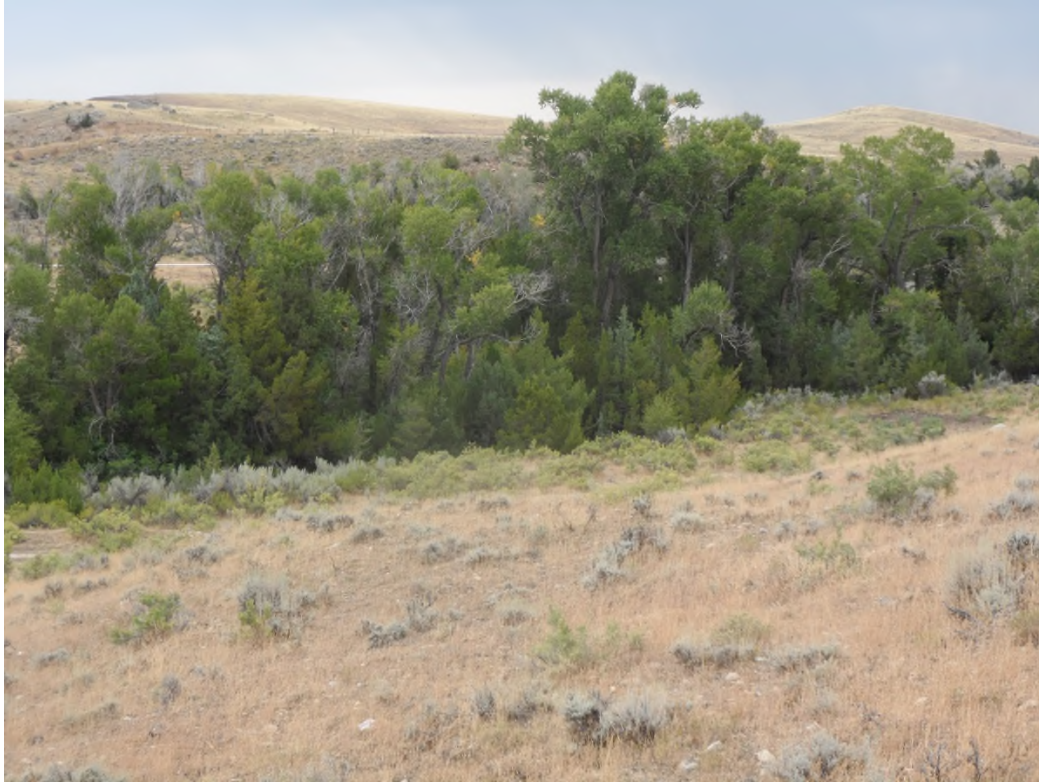
Photograph 3. Representative mixed forest community along the supply line and diversion dam area along Beaver Creek.

A total of 3.35 acres of non-wetland woody riparian communities were identified along named waterways (Table 1). The waterways included multiple locations along Beaver Creek, Shell Creek, and the existing dam outflow. A mature mixed-forest community was identified along Beaver Creek (supply line and diversion dam location; polygons 10, 11, and 12). Forested species identified included plains cottonwood (*Populus deltoides*), lanceleaf cottonwood (*Populus deltoids*), Rocky Mountain juniper (*Juniperus scopulorum*), and river birch (*Betula occidentalis*), with an understory of river birch, buffaloberry (*Shepherdia argentea*), and chokecherry (*Prunus virginiana*). Cottonwoods were the dominant species in the riparian area (Photo 3). A similar species composition was identified along the second Beaver Creek location (pipeline to Beaver Creek; polygons 13 and 14); however, fewer large cottonwoods were observed and Russian olive, salt cedar, and sandbar willow were present (Photo 4). The forested community along the back of the dam also had a similar species composition (Photo 5; polygon 7, 8 and 9). The Shell Creek non-wetland woody riparian community was dominated by

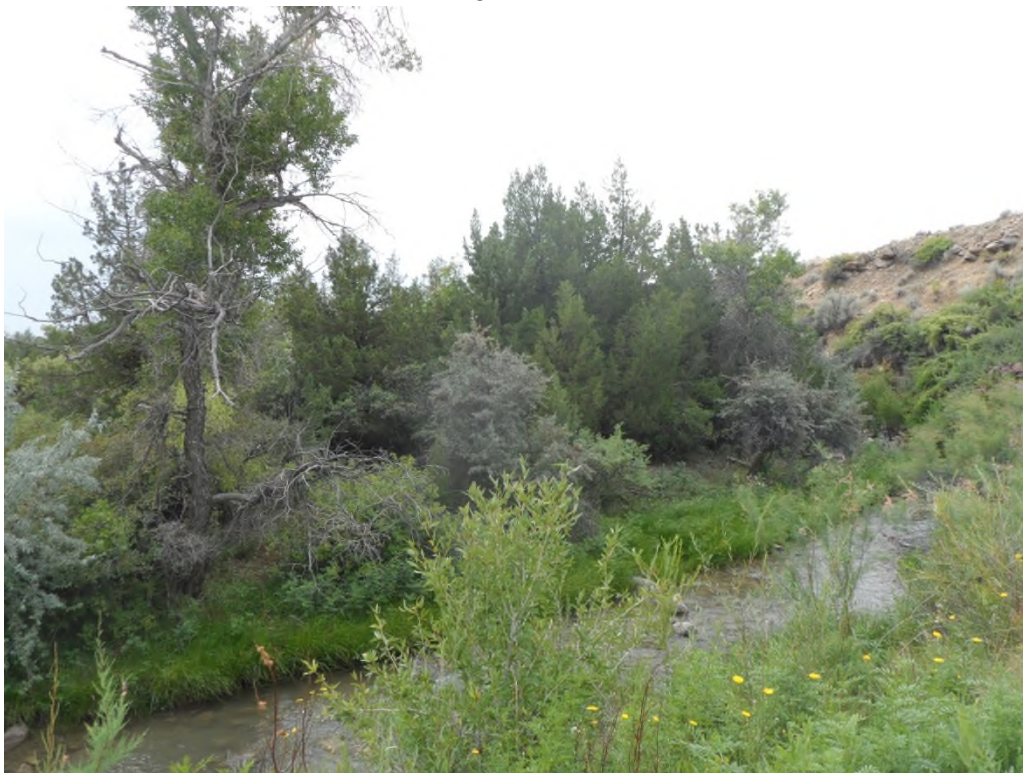
Photograph 4. Representative mixed forest community in the pipeline corridor to Beaver Creek area.

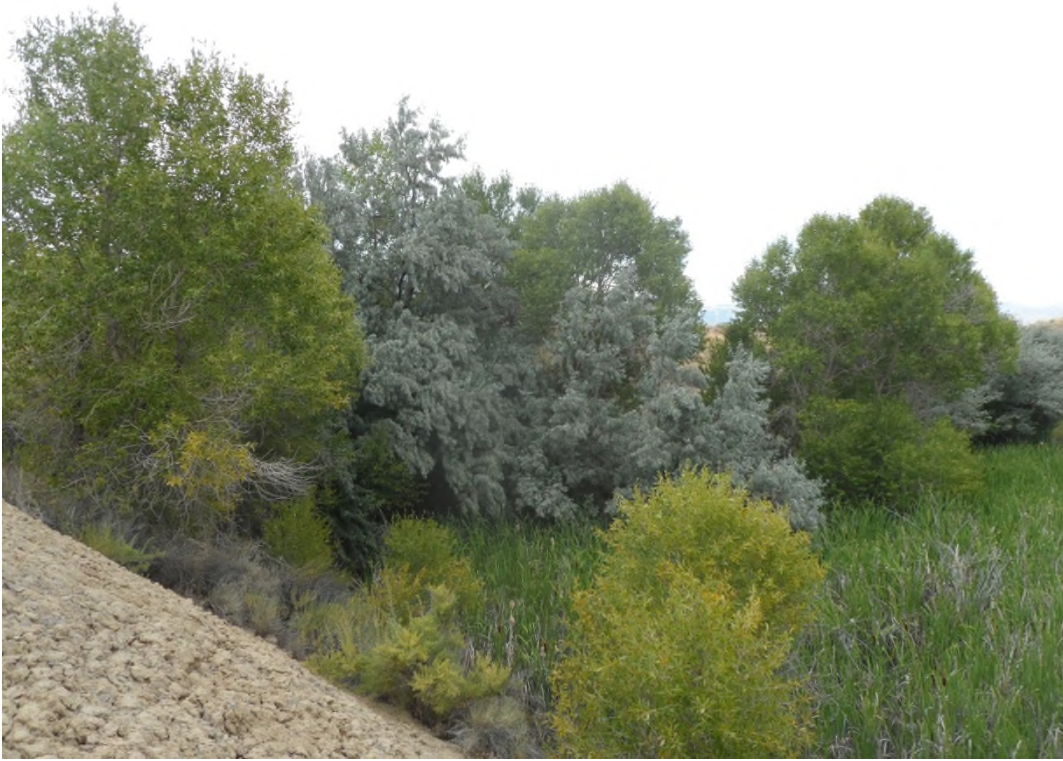
Photograph 5. Representative mixed forest community on the back of the existing dam.

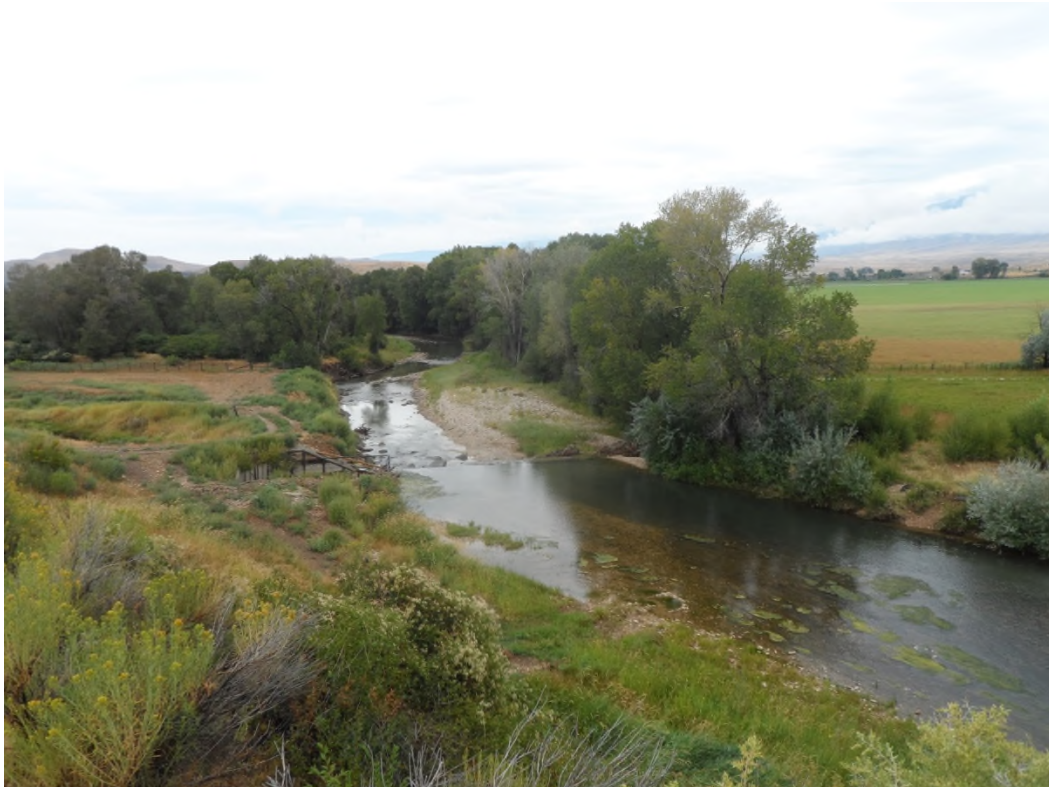
Photograph 6. Representative mixed forest community in the transfer line area (Shell Creek crossing location).

mature cottonwood trees, with a smaller percentage of Russian olive at the creek crossing location (Photo 6; polygons 16, 17, 18).

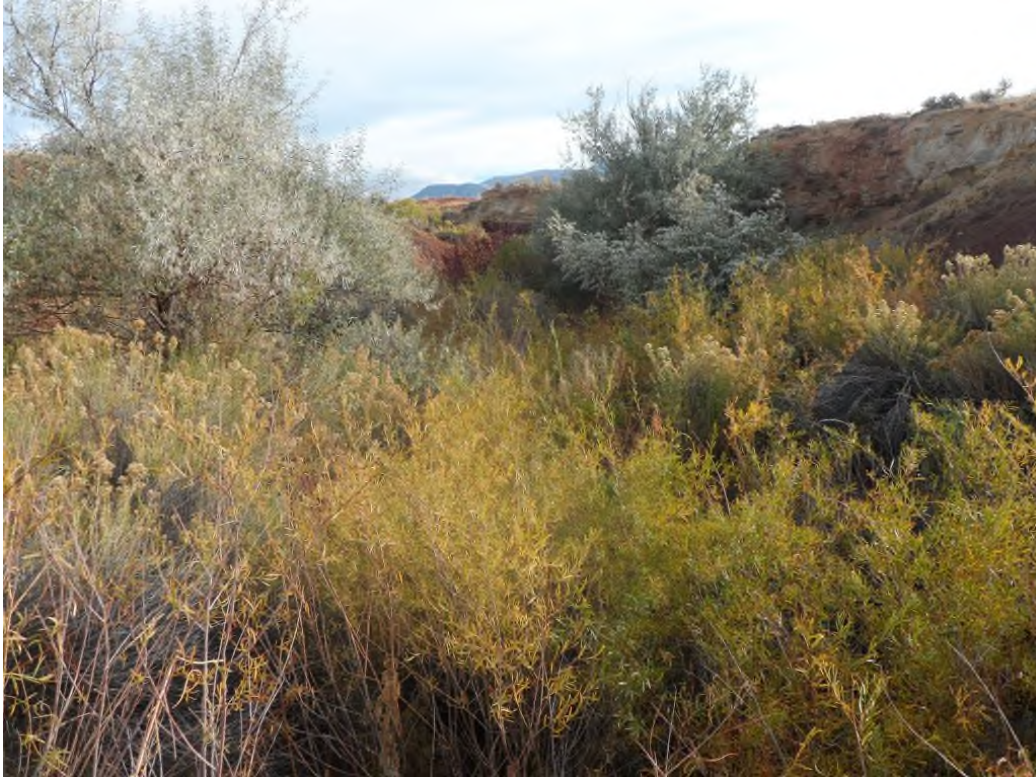
Photograph 7. Representative mixed shrub community along the existing Leavitt supply ditch.

Only 0.46 acres of other non-wetland woody riparian areas were identified. These included a mixed shrub community (sandbar willow and Russian olive; Photo 7; polygons 1 and 2) along the existing Leavitt supply ditch and scattered Russian olive trees at the transfer diversion dam along Beaver Creek (Photo 8; polygon 15).

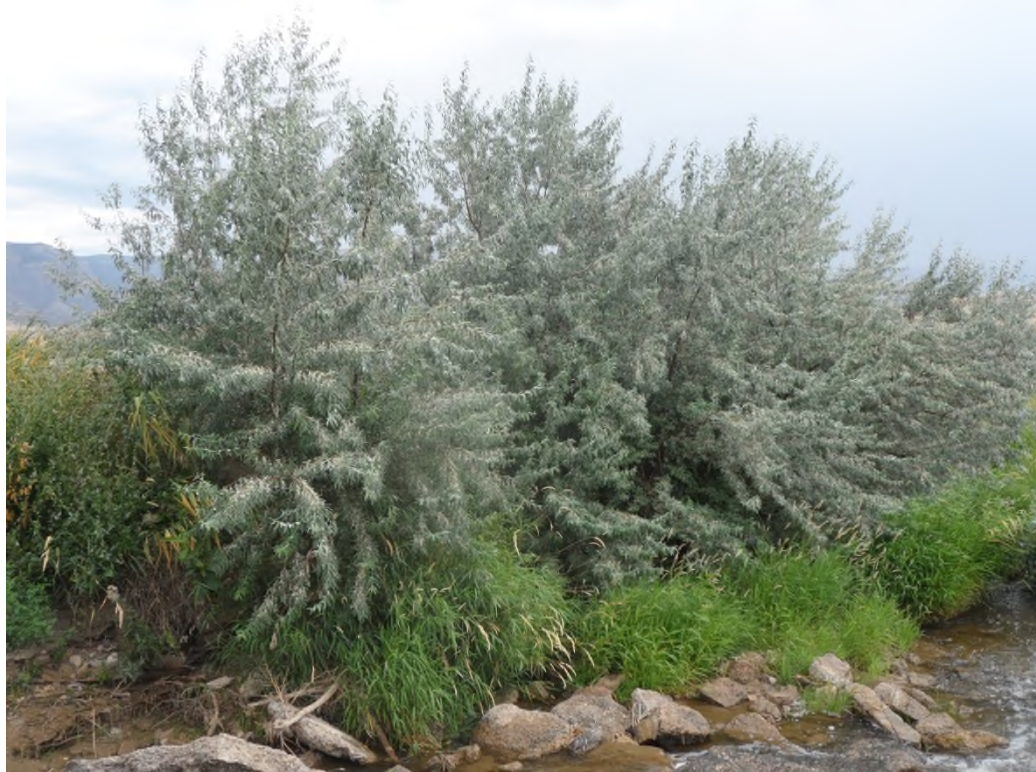
Photograph 8. Representative Russian olive community in the transfer line diversion dam area.

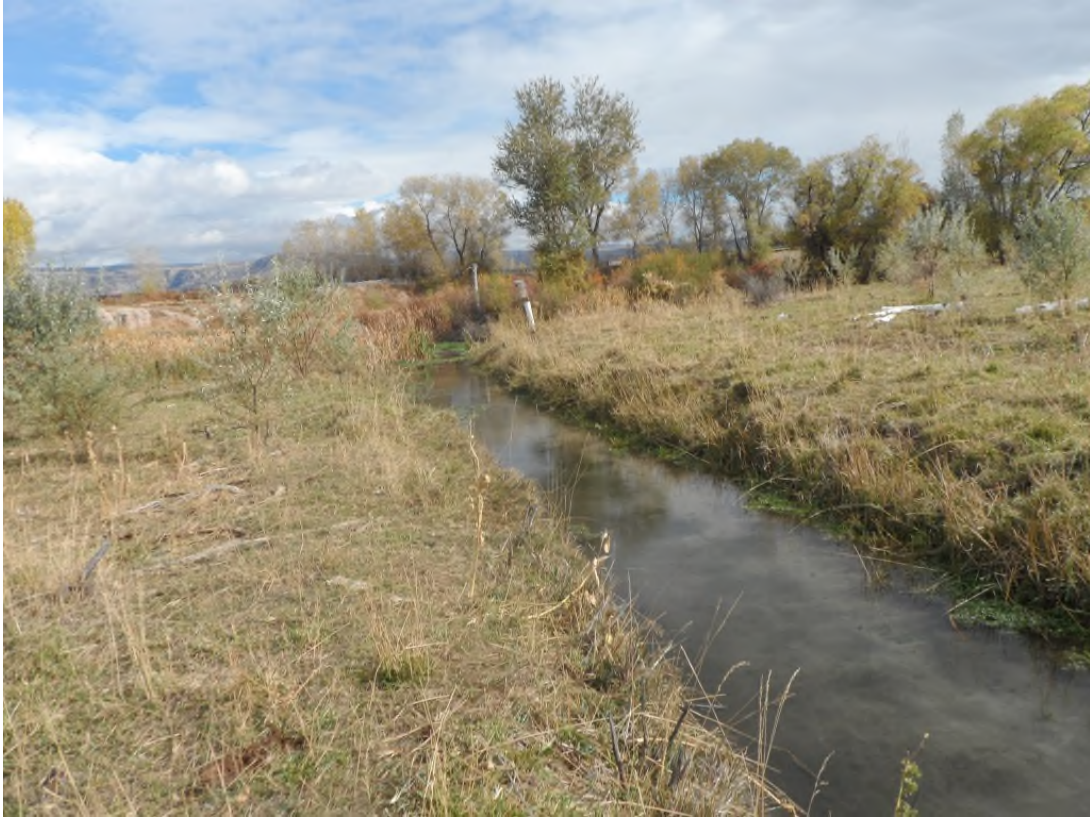
Photograph 9. View east into the non-surveyed area; cottonwood trees in background were not surveyed during the formal field effort.

One polygon in the disturbance area was not formally surveyed. Based on notes and photos collected during the field effort, cottonwood trees and scattered Russian olives occur in the non-surveyed sections (Photo 9). Most of the non-surveyed area is row crops.
